# **INDOOR AIR QUALITY ASSESSMENT**

**Goodyear Elementary School  
41 Orange Street  
Woburn, Massachusetts**

Prepared by:  
Massachusetts Department of Public Health  
Center for Environmental Health  
Emergency Response Indoor Air Quality Program  
August 2005

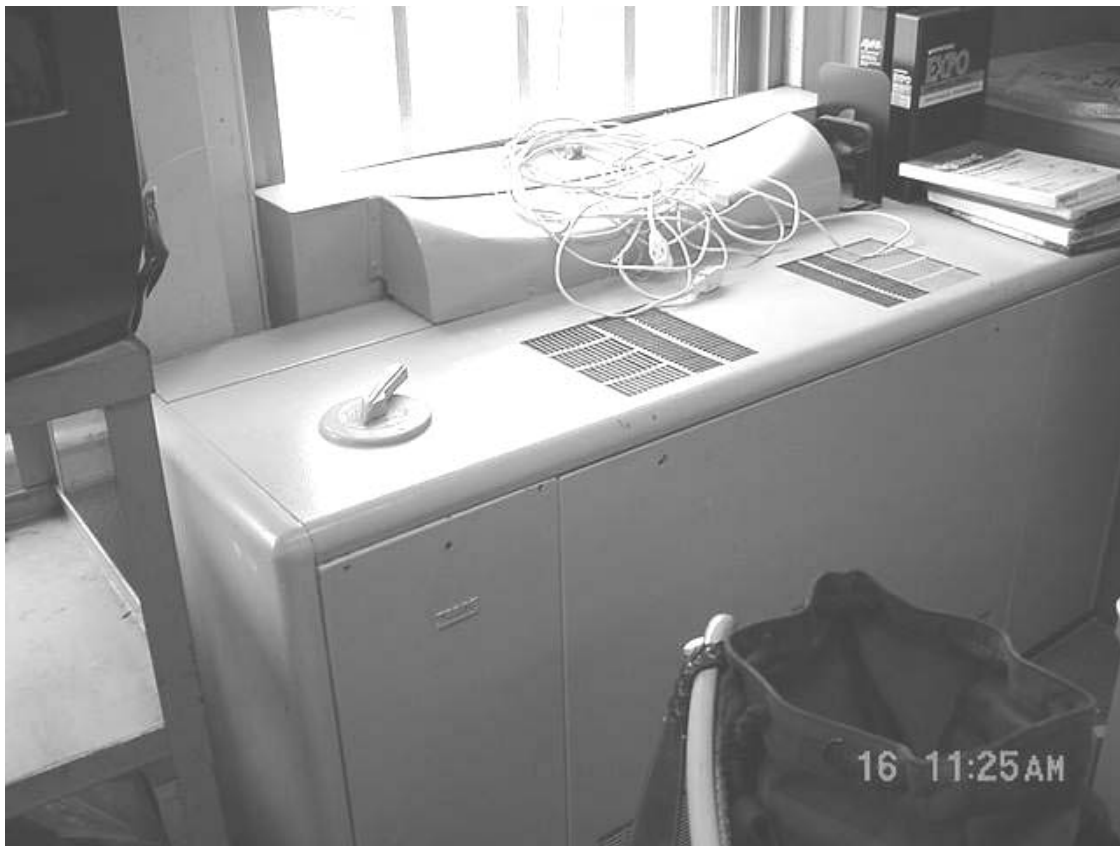
**Picture 1**

Fresh air in classrooms of the 1926 and 1964 sections of the building is supplied by unit ventilator (univent) systems (Pictures 1 and 2). A univent is designed to draw air from outdoors through a fresh air intake located on the exterior wall of the building (Pictures 3 and 4). Univents in the 1926 section of the building do not have air intakes on exterior walls but are equipped with a vent scoop on the top of univents (Picture 1), which require the opening of windows to introduce fresh air into the units. Return air is drawn through an air intake located at the base of each unit ([Figure 1](#)). Fresh and return air are mixed, filtered, heated and provided to classrooms through an air diffuser located in the top of the unit.

Univents appear to be original equipment, approximately 35 to 75 years old. Function of such aged equipment is difficult to maintain, since compatible replacement parts are often unavailable. Due to the age of the equipment, univents in the 1926 section of the building were not operating at the time of the assessment. As a result, no mechanical means for providing fresh air to these classrooms exists. Univents in the 1964 wing were operating weakly; therefore the introduction of outside air was limited. To facilitate air exchange, Mr. Lamson has stationed portable fan units on top of univent air diffusers (Picture 2). The nurse's office and resource room 18 have neither windows nor mechanical or passive ventilation for air exchange. A fresh air source is necessary for the dilution of indoor air pollutants.

**Classroom Univent 1920's Vintage, Note Vent "Scoop" on top of Unit Requiring the Opening of Windows to Introduce Fresh Air**

1. Consider consulting a heating, ventilation and air conditioning (HVAC) engineer concerning the optimal operability of univents.
2. Operate all ventilation systems that are operable throughout the building (e.g., gym, auditorium, classrooms) continuously during periods of school occupancy independent of thermostat control to maximize air exchange.

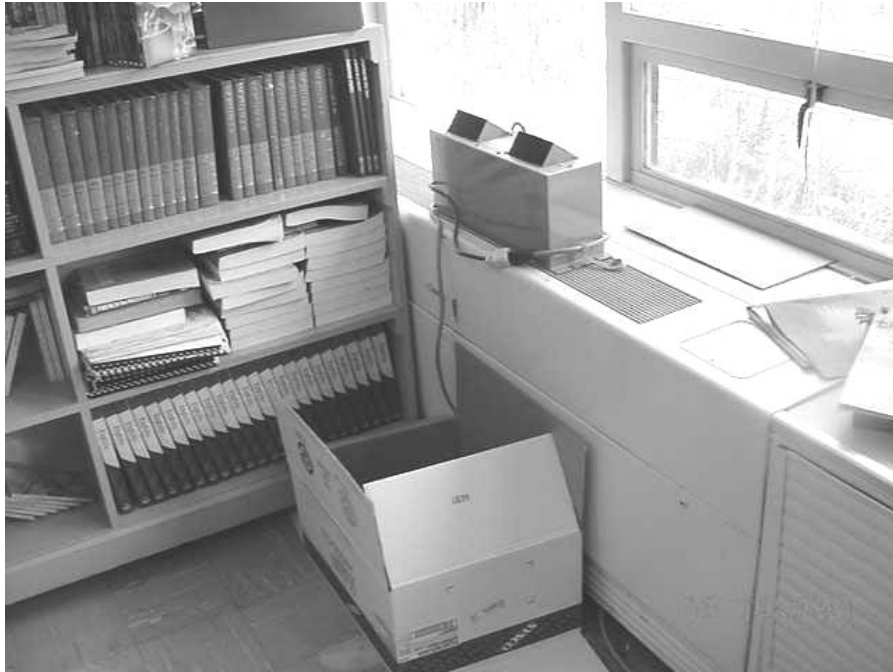
**Picture 2**

recommended comfort guidelines during the assessment. The MDPH recommends that indoor air temperatures be maintained in a range of 70° F to 78° F in order to provide for the comfort of building occupants. In many cases concerning indoor air quality, fluctuations of temperature in occupied spaces are typically experienced, even in a building with an adequate fresh air supply. Complaints of extreme temperature, mostly cold, were expressed in a number of areas, primarily in the 1964 wing. Temperature control is often difficult in a building with abandoned or nonfunctioning ventilation systems and loose/drafty single paned windows. As discussed earlier, to help achieve comfortable temperatures in the 1964 wing, supplemental heating fans are stationed on top of univent air diffusers (Picture 2).

**Classroom Univent 1960's Vintage, Note Portable Fan Unit on Air Diffuser to Facilitate Air Exchange**

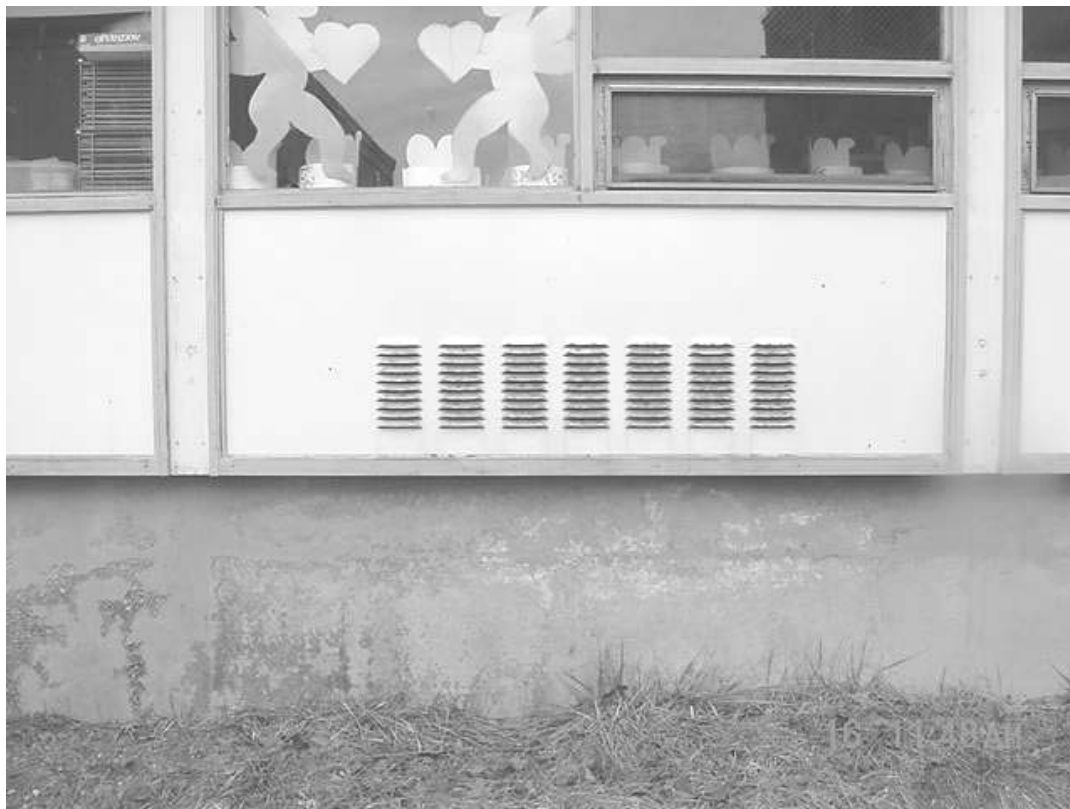
**Picture 3**

**Univent Air Intake for 1964 Wing**

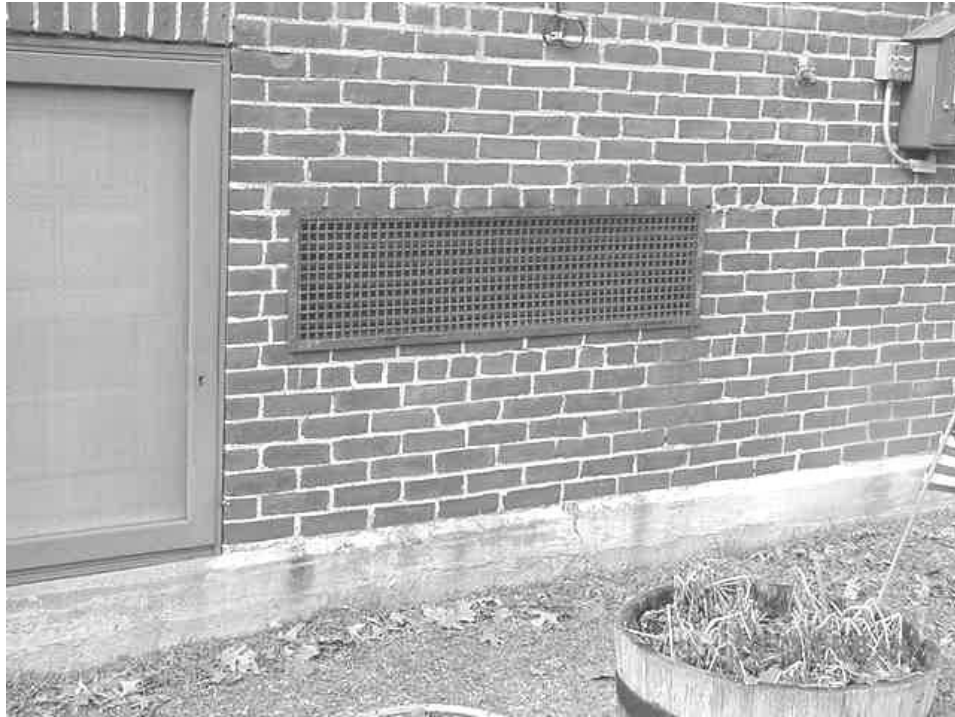
**Picture 4**

**Univent Air Intake for 1964 Wing**

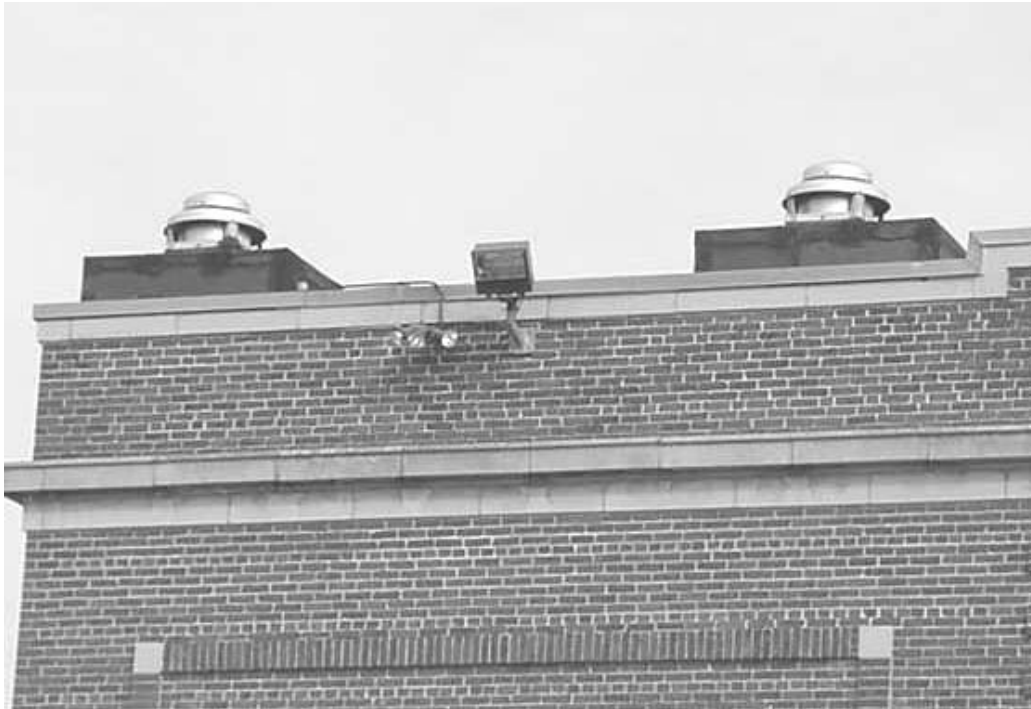
**Picture 5**

Exhaust vents powered by rooftop motors (Picture 5) are located in coat closets. The location of exhaust vents allows for them to be easily blocked by stored materials (Pictures 6

**Rooftop Exhaust Motors**

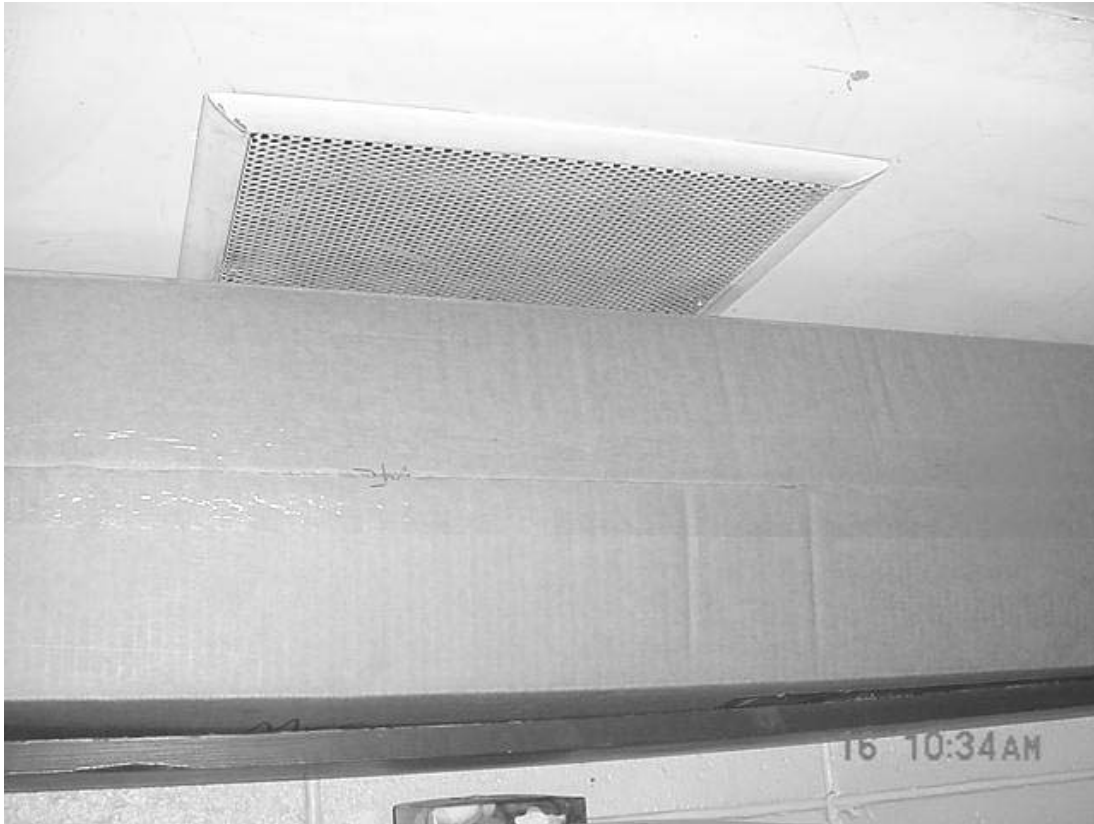
**Picture 6**

and 7). In order to function properly, these vents must remain free of obstructions. All exhaust vents were operating throughout the building during the assessment.

**Coat Closet Exhaust Vent Obstructed by Box**

3. Remove all blockages from univents and exhaust vents to ensure adequate airflow.
4. Use openable windows in conjunction with classroom exhaust vents to create air exchange. Care should be taken to ensure windows are properly closed at night and weekends to avoid the freezing of pipes and potential flooding.

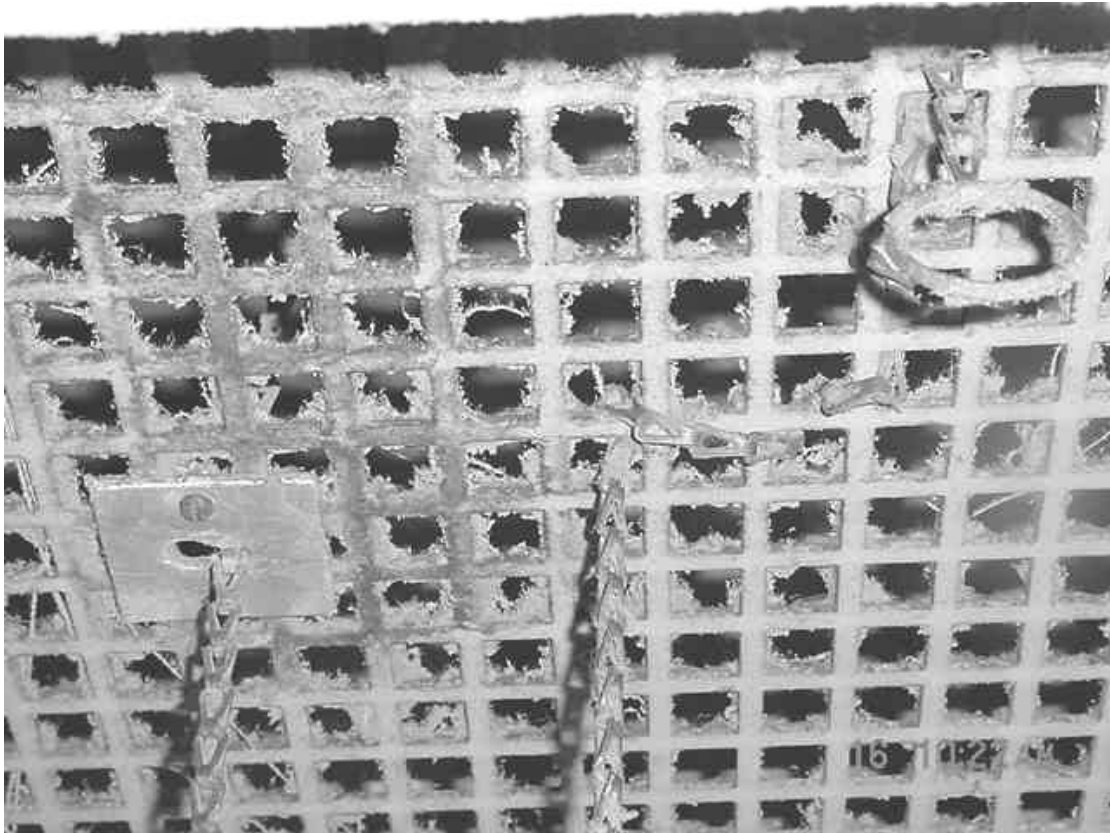
**Picture 7**

**Close-Up of Coat Closet Exhaust Vent, Note Pull Chain to Adjust Flue and Dust Accumulation**

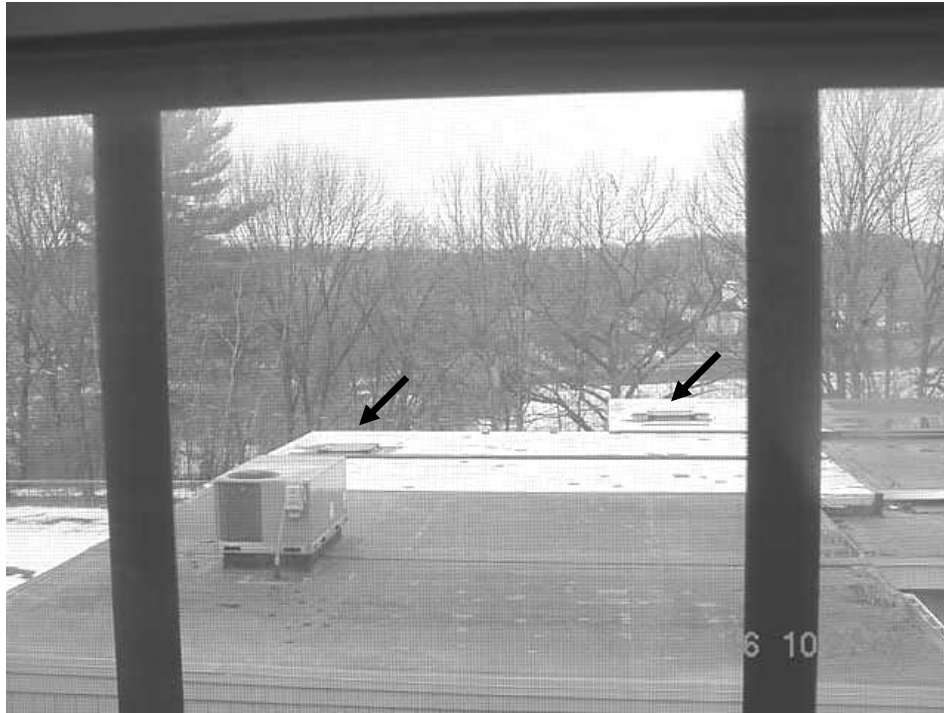
**Picture 8**

Ventilation for modular classrooms was originally provided by rooftop air-handling units (AHUs). All AHUs, with the exception of the one shown in Picture 8, have been removed due to chronic roof leaks; therefore, openable windows remain the only means to introduce fresh air into these rooms. The rooftop AHU in Picture 8 (Mrs. Lane's room) distributes air into the classrooms via ductwork connected to ceiling-mounted air diffusers. Return vents draw air back to the AHU through ceiling-mounted grilles. A thermostat controls the AHU and has fan settings of "on" and "automatic". The automatic setting on the thermostat activates the ventilation system at a preset temperature. Once the preset temperature is reached, the system is deactivated. Therefore, no mechanical ventilation is provided until the thermostat re-activates the system. The thermostat in Mrs. Lane's room was set to the fan "on" setting during the assessment, which provides continuous air exchange.

**Sole Remaining AHU, Arrows Indicate AHUs That Have Been Removed**

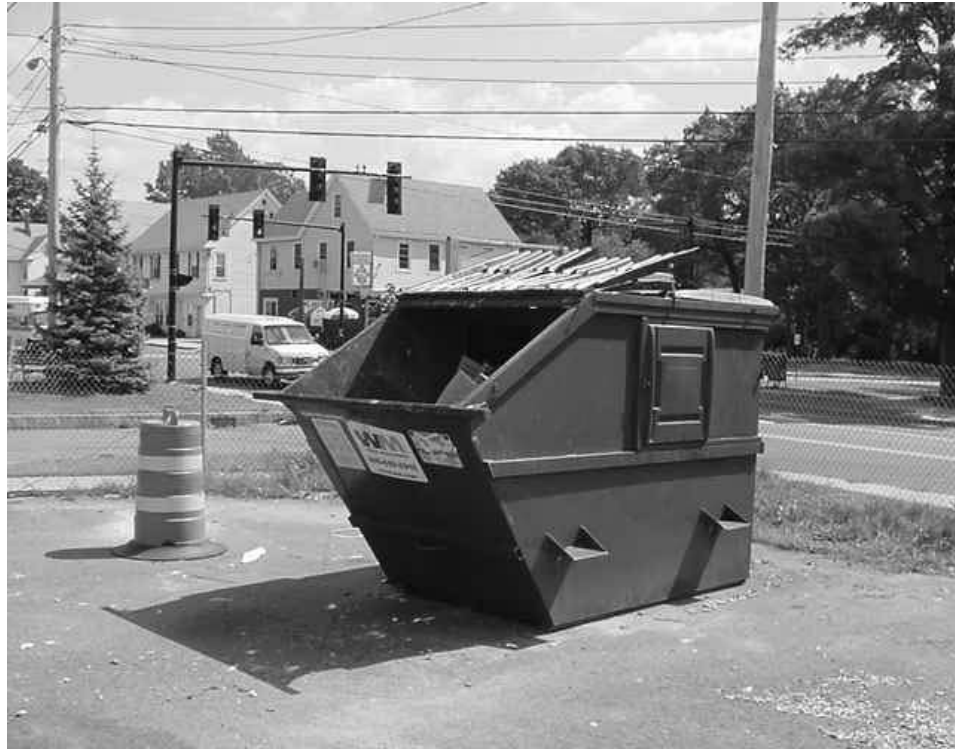
**Picture 9**

During the September 3, 2004 visit, Mr. Feeney (Director of MDPH's ER/IAQ program) observed the remediation of water damaged materials in the modular classroom wing. Water damaged materials were removed and discarded in a dumpster located at the front of the school's parking lot (Pictures 9 and 10). The following remediation steps were taken to repair water damage to the modular classroom wing:

**Dumpster In Front Of Building**

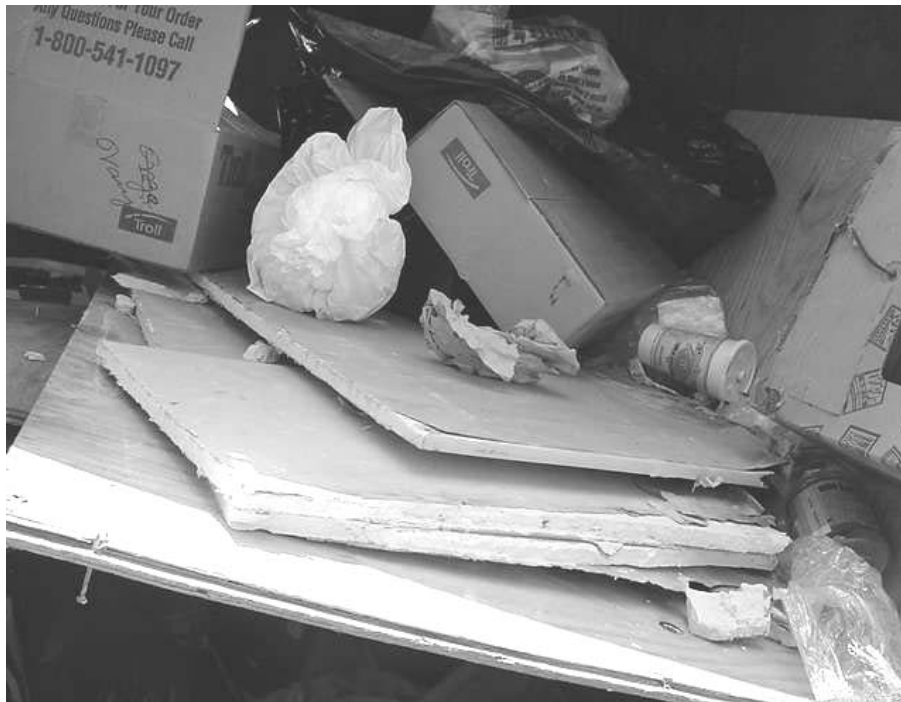
**Picture 10**

**Moldy Gypsum Wallboard and Other Demolition Materials Related To Modular Renovations**

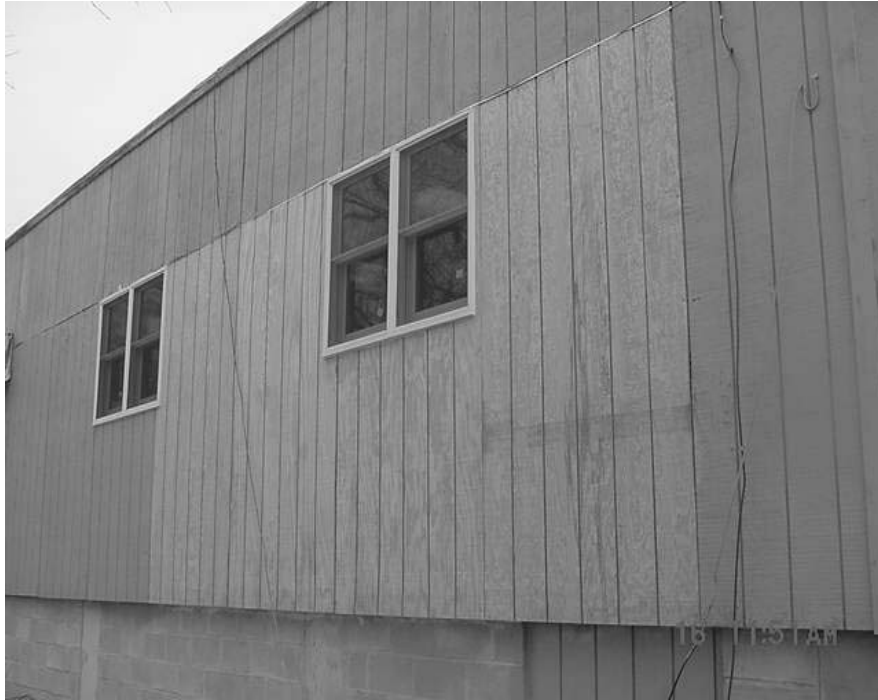
**Picture 11**

- Water damaged gypsum wallboard was removed and replaced.
- Rotted exterior wooden walls were removed and replaced (Picture 11).
- Water damaged carpeting was removed. New carpeting was being installed during this assessment.

**Fully Repaired Exterior, West Wall of Modular Classroom**

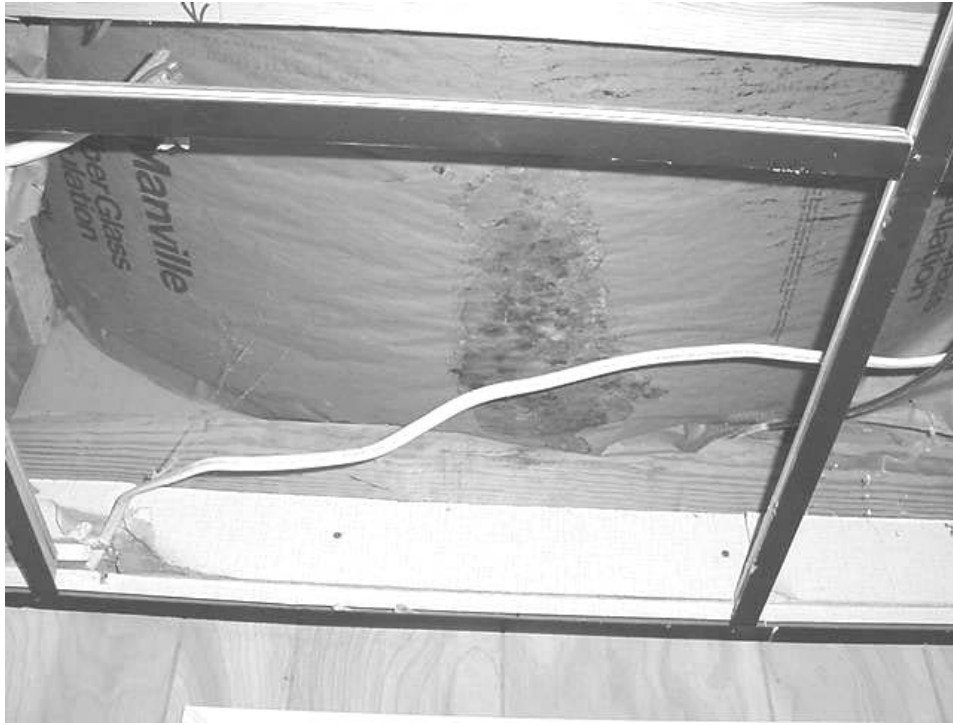
**Picture 12**

**Moldy Insulation**

In addition to these steps, Mr. Feeney also recommended that water damaged insulation (Picture 12) be discarded and that mold be cleaned from roof rafters (Picture 13).

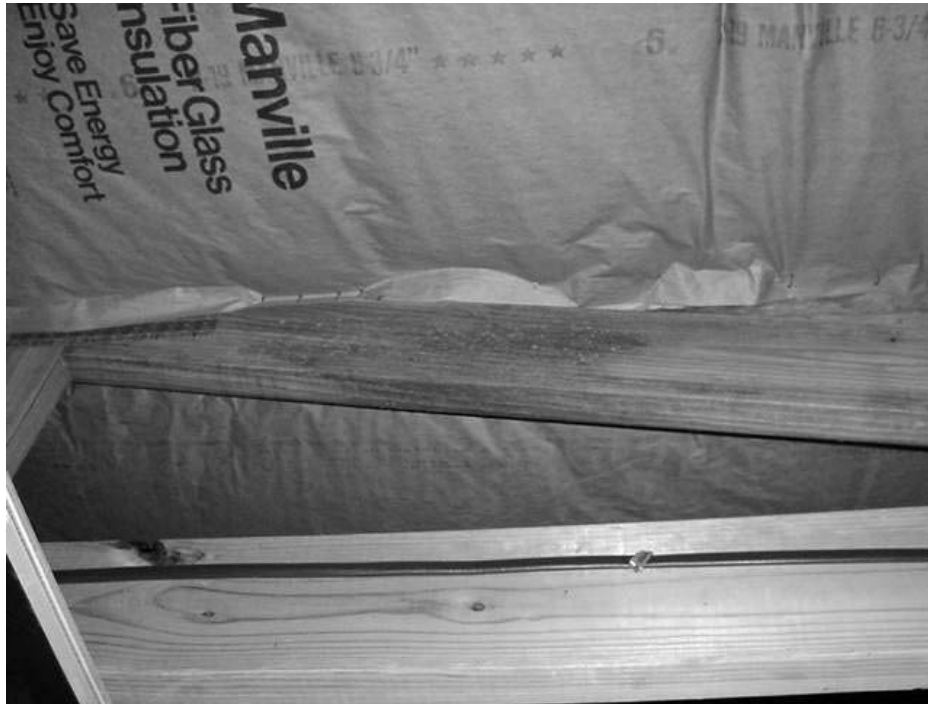
**Picture 13**

**Mold Contaminated 2' X'4' Rafter, Modular Classroom**

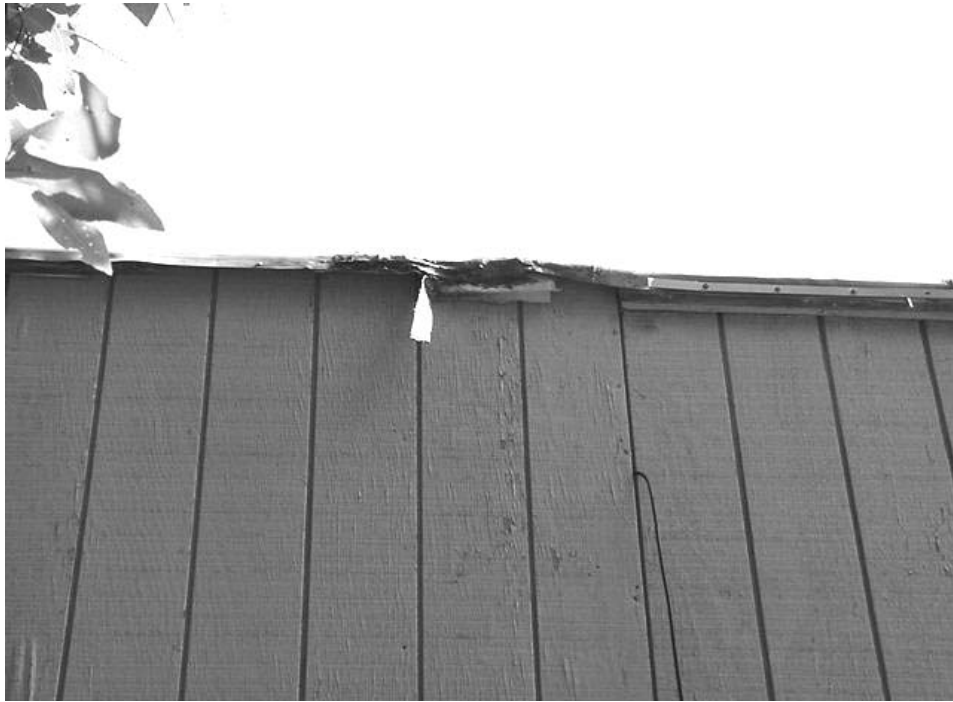
**Picture 14**

The likely cause of the water damage was a lack of appropriate water drainage from the roof. Exterior walls of the modular classrooms showed signs of water damage, as a result of leaks from the gutter/downspout system. The water damage in the repaired section was directly under a roof spillway (Picture 14) that directed rainwater off the slightly sloped roof. This type of drainage allows water to chronically wet the exterior wall below this spillway, thereby degrading the wall surface and allowing water penetration to the interior. In order to avoid further damage to the exterior wall, water drainage from the modular roof should be configured in a manner to prevent rainwater from draining down the exterior wall.

**Spillway without Gutter/Downspout, West Wall, Modular Classrooms**

8. Repair leaks to gutters and downspouts on the roof of modular classrooms, if not already accomplished.
9. Contact a masonry firm or general contractor to repair holes/breaches in exterior walls to prevent water penetration, drafts and pest entry.

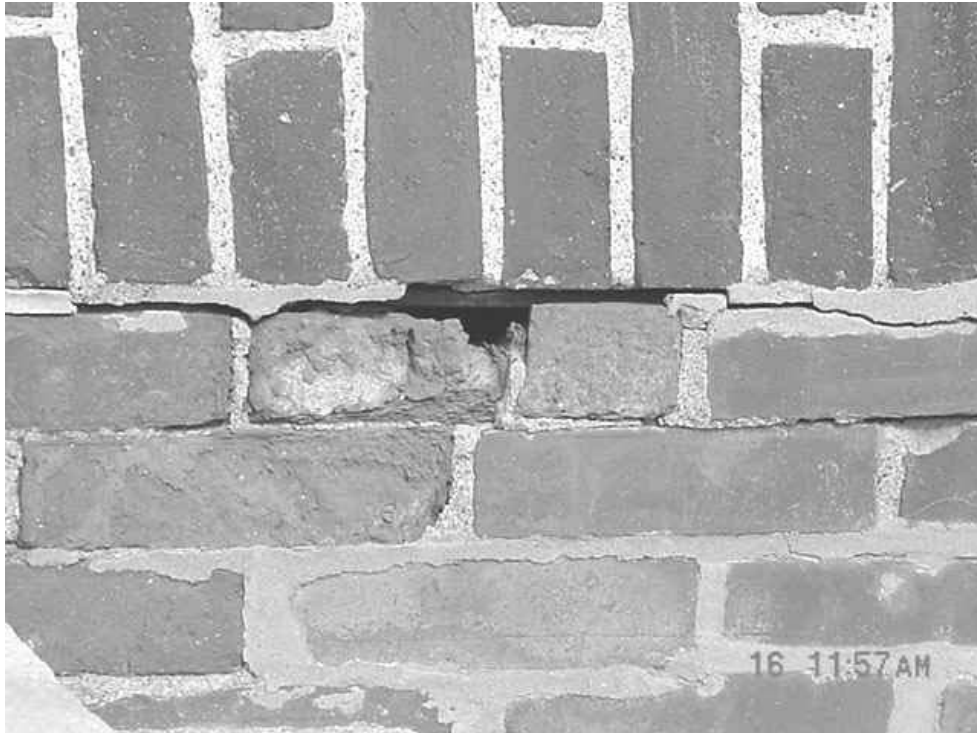
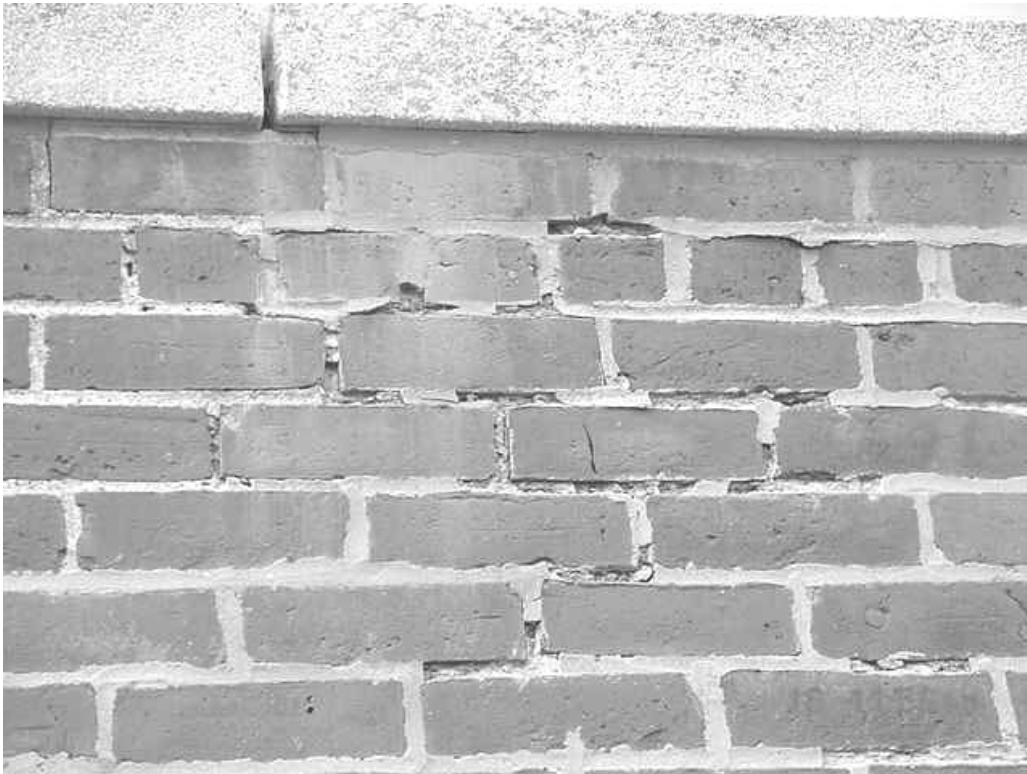
Exterior walls had spaces/cracks in brickwork. In many areas mortar around exterior brickwork appeared to be crumbling or missing (Pictures 15 and 16). These conditions are breaches of the building envelope and can provide a means for water entry into the building. Repeated water penetration can result in the chronic wetting of building materials and the potential for microbial growth. In addition large wall cracks may provide a means of egress for pests/rodents into the building.

**Missing/Damaged Mortar/Brickwork**

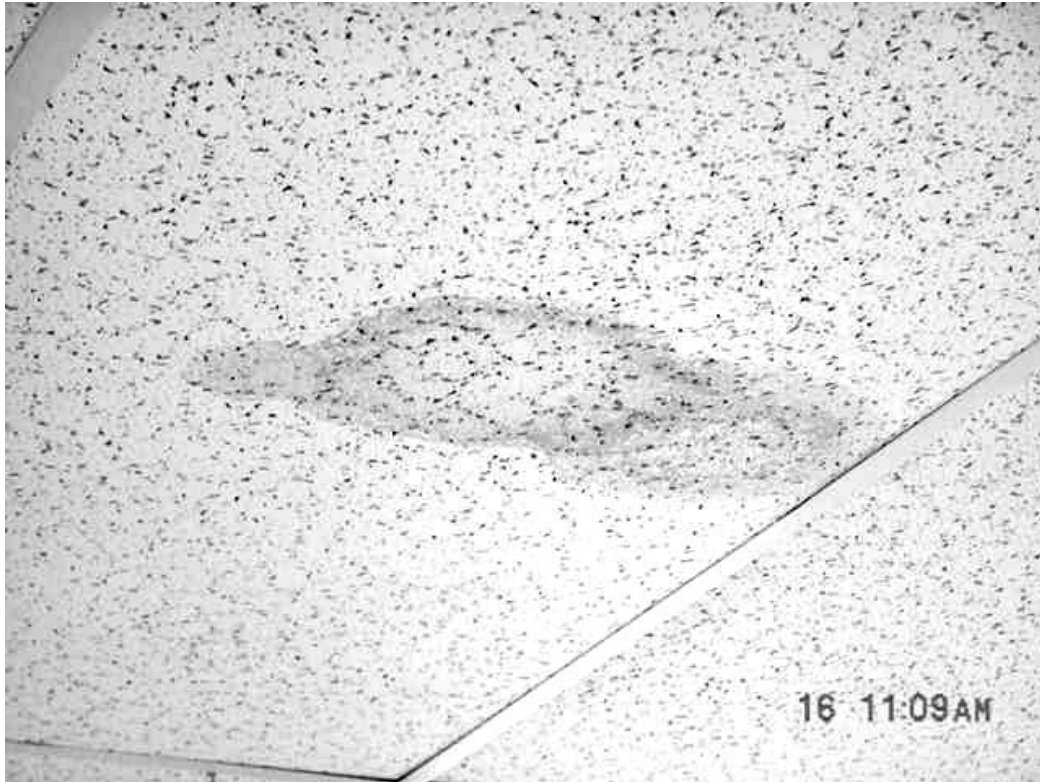
**Picture 17**

A number of areas had water-stained ceiling tiles, which can indicate leaks from the roof or plumbing system (Picture 17). Water-damaged porous building materials can provide a source for mold and should be replaced after a water leak is discovered and repaired.

**Water Damaged Ceiling Tile**

7. Ensure leaks are repaired and replace water damaged ceiling tiles. Examine the area above and around these areas for mold growth. Disinfect areas of water leaks with an appropriate antimicrobial.

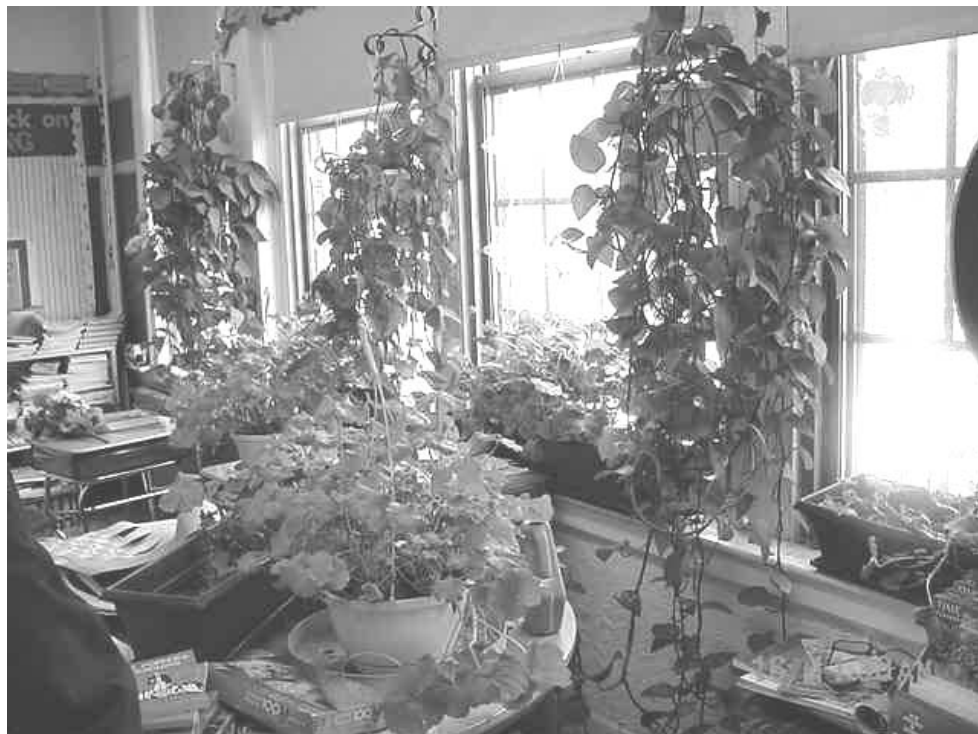
**Picture 18**

Plants were noted in several classrooms (Picture 18). Plants can be a source of pollen and mold, which can be respiratory irritants for some individuals. Plants should be properly maintained and equipped with drip pans. Plants should also be located away from univents to prevent the aerosolization of dirt, pollen or mold.

**Plants in Classroom**

10. Repair/replace broken windows; re-seal loose window frames to prevent drafts and water penetration.
11. Ensure plants have drip pans. Examine drip pans periodically for mold growth and disinfect with an appropriate antimicrobial where necessary. Keep plants away from the air stream of univents. Consider reducing the number of plants in certain areas.

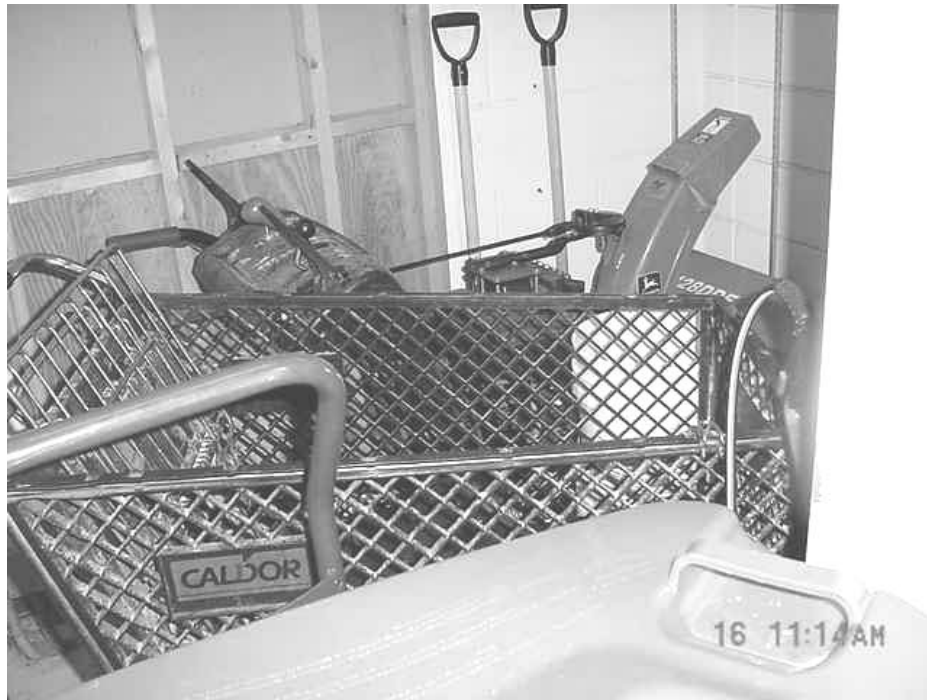
**Picture 19**

February 16, 2005 follow-up assessment, a gas-powered snow blower was being stored in room 18, which is a small interior room with no mechanical supply ventilation or openable windows (Picture 19). Odors and off-gassing of VOCs from gasoline can have an adverse effect on indoor air quality. The alternative storage area for the snow blower is reportedly the crawlspace underneath the portable classrooms (Picture 20); odors and fumes can potentially migrate to the above classrooms.

**Snow Blower (Behind Shopping Cart) Stored in Room 18**

12. Encapsulate exposed pipe insulation to avoid the aerosolization of fiberglass fibers.
13. Store gas-powered equipment outside the building.
14. Store cleaning products properly and out of reach of students.

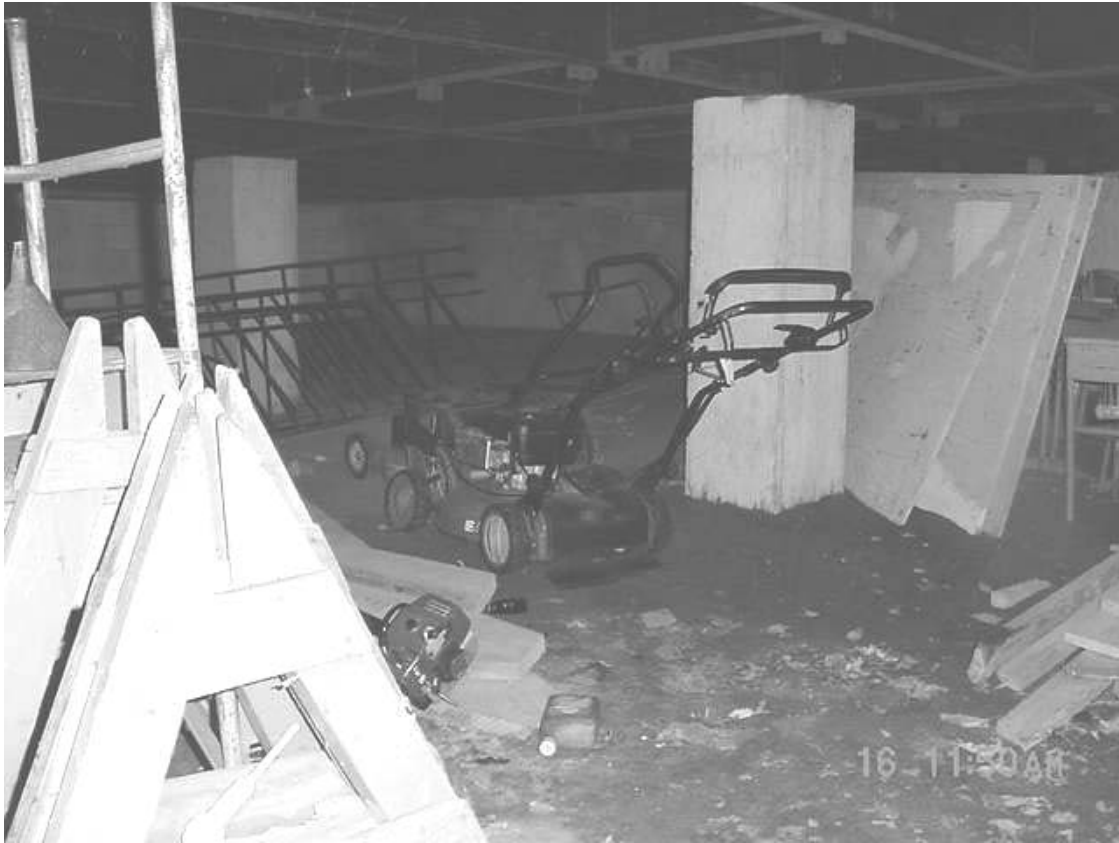
**Picture 20**

**Crawlspace Beneath Modular Classrooms, Note Gas Powered Mower and Edger**

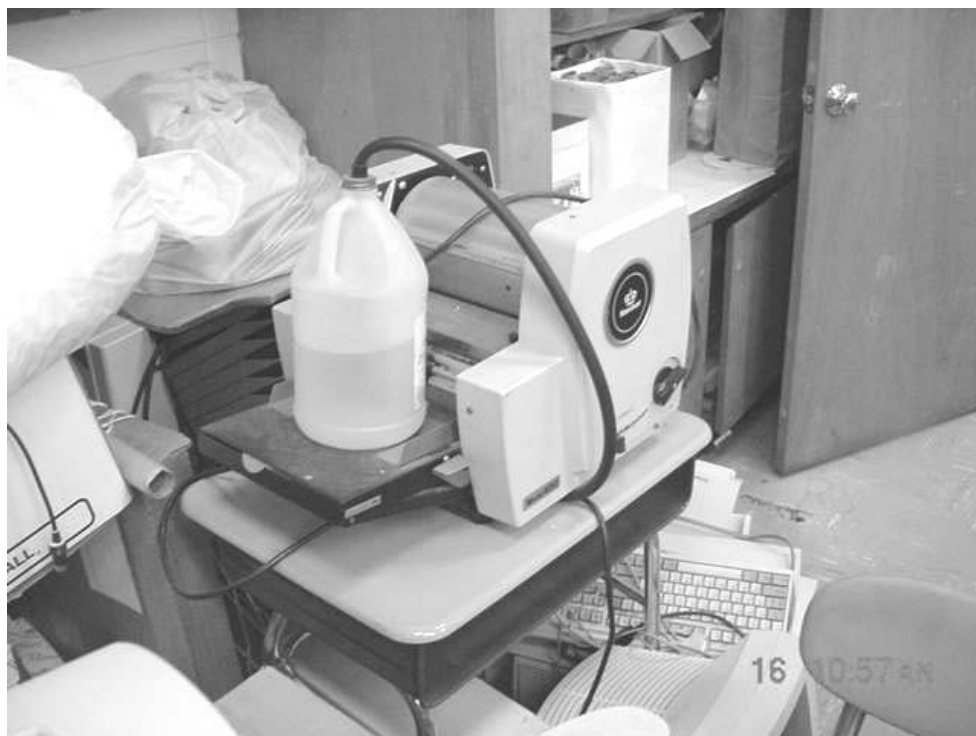
**Picture 21**

The computer room contained a mimeograph machine (Picture 21), which can produce irritating odors during use. Mimeograph duplicating fluid contains methanol (methyl alcohol), which is a VOC that readily evaporates at room temperature. The off gassing of this material can be irritating to the eyes, nose and throat. Methanol is also a highly flammable material, which can be ignited by either flame or electrical source (Picture 22).

**Mimeograph Machine With Flammable Duplicating Fluid**

15. Consider discontinuing the use of mimeograph machine.
16. Relocate or consider reducing the amount of materials stored in classrooms to allow for more thorough cleaning of classrooms. Clean items regularly with a wet cloth or sponge to prevent excessive dust build-up.

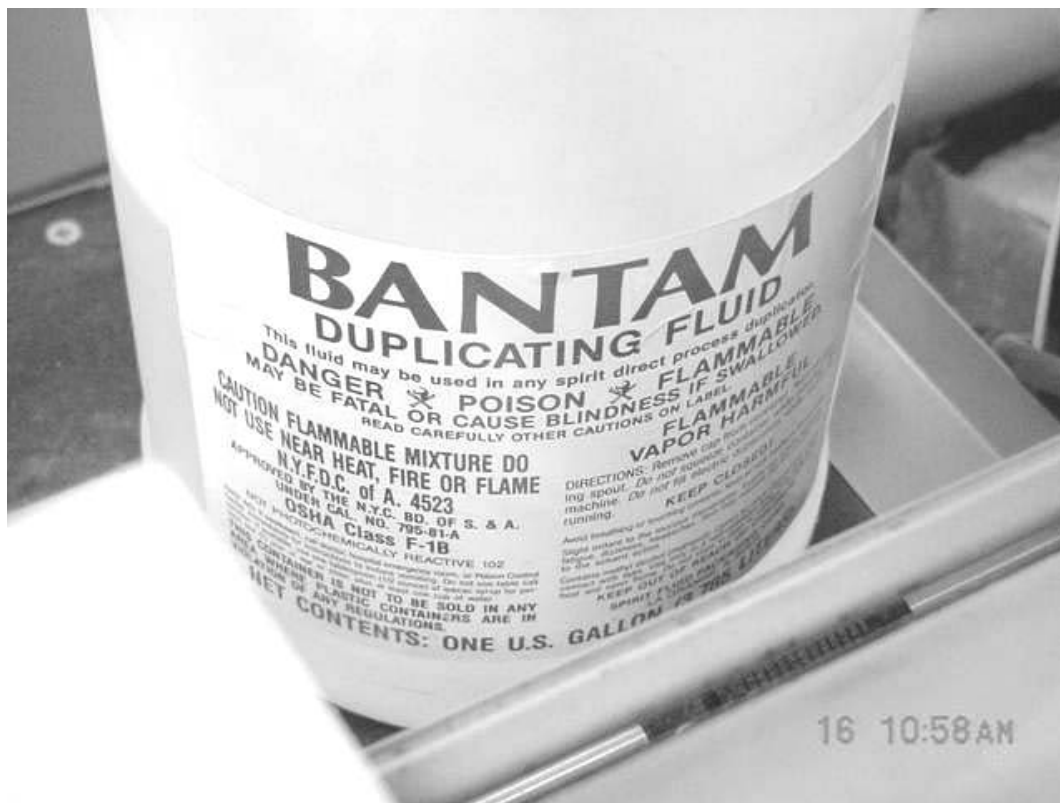
Picture 22

Close-Up of Poison/Flammable Label on Duplicating Fluid

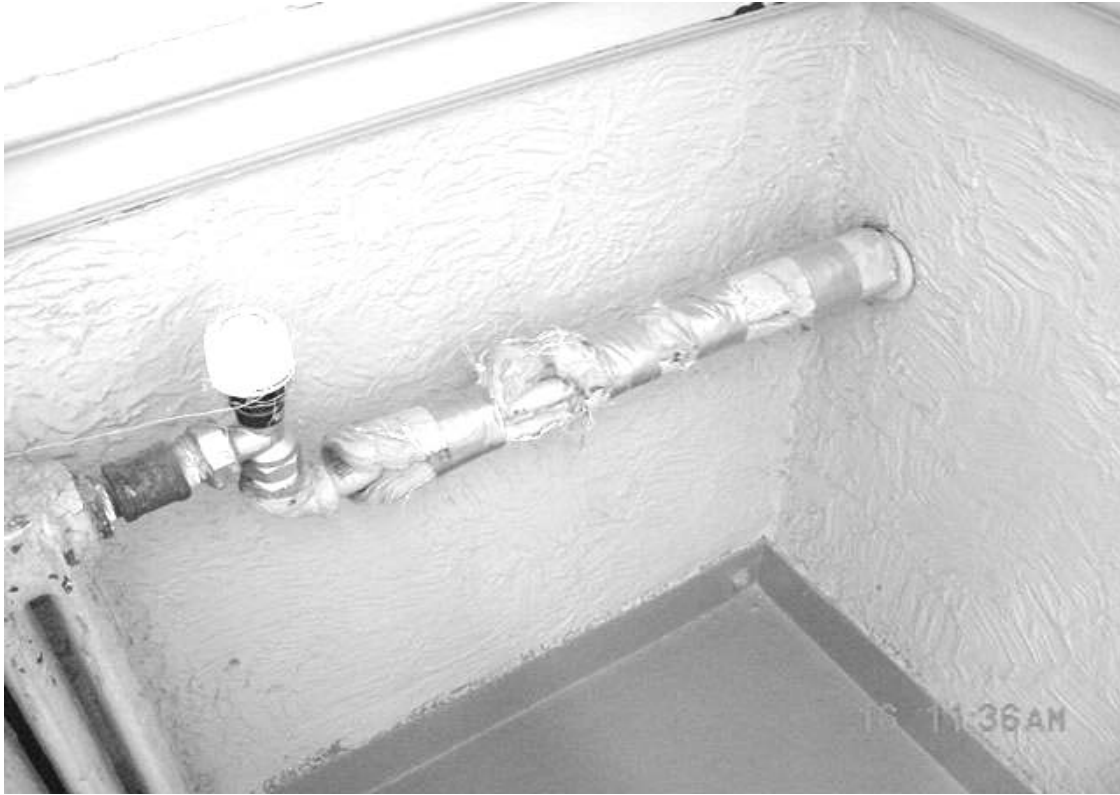
**Picture 23**

Several other conditions that can affect indoor air quality were noted during the assessment. Exposed fiberglass insulation was noted around pipes (Picture 23). Fiberglass insulation can be a source of skin, eye and respiratory irritation.

**Exposed Fiberglass Pipe Wrap**
